Flight Test Experience and Controlled Impact of a Large, Four-Engine, Remotely Piloted Airplane

Robert W. Kempel and Timothy W. Horton

August 1985

1 Report No NASA TM-86738	2 Government Accession No	3 Recipient's Catalog No	
4 Title and Subtitle FLIGHT TEST EXPERIENCE AND CONTROLLED IMPACT OF A LARGE, FOUR-ENGINE, REMOTELY PILOTED AIRPLANE		5 Report Date August 1985	
		6 Performing Organization Code	
7 Author(s) Robert W. Kempel and Timothy W. Horton		8 Performing Organization Report No H-1298	
9 Performing Organization Name and Address NASA Ames Research Center Dryden Flight Research Facility P.O. Box 273 Edwards, CA 93523		10 Work Unit No RTOP 505-45-11	
		11 Contract or Grant No	
12 Sponsoring Agency Name and Address National Aeronautics and Space Administration Washington, D.C. 20546		13 Type of Report and Period Covered Technical Memorandum	
		14 Sponsoring Agency Code	
15 Supplementary Notes This document was prepared for the SFTE 16th Annual Symposium, Seattle, Washington, July 29-August 2, 1985.			
16 Abstract <p>NASA Ames Research Center's Dryden Flight Research Facility and the Federal Aviation Administration conducted the controlled impact demonstration (CID) program

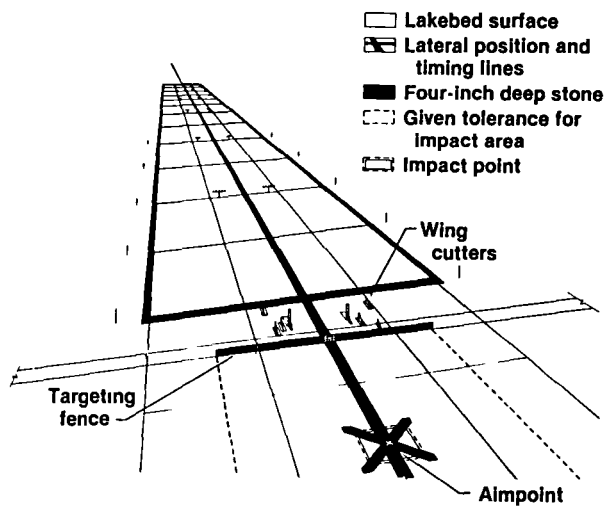
Figure 1 shows the layout of the crash site. The triangular obstacles are "wing cutters," designed to open wing fuel tanks to ensure dispersal of AMK. The heavy horizontal line was a fence 2.4 m (8 ft) high, made of frangible material which aided the RPV pilot in the targeting task. Where the centerline intersects the fence, a bright orange panel was placed to provide the RPV pilot a visual guidance aimpoint.

Figure 1. Controlled Impact Demonstration Aircraft Crash Site

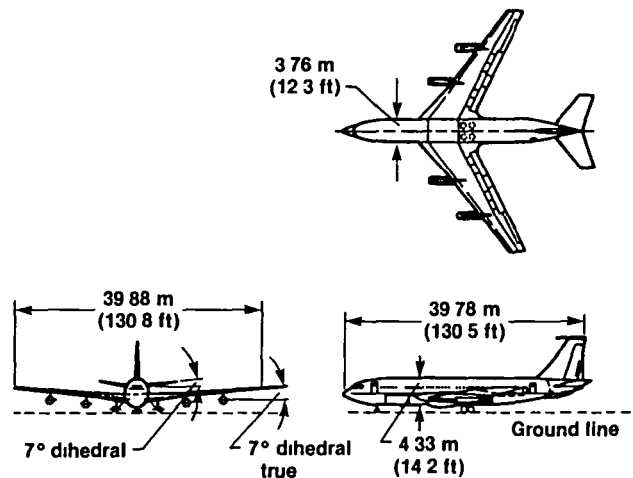
The Boeing B-720 airplane is a swept-wing, swept-tail, four-engine, medium-range jet transport. The principal physical dimensions of the B-720 are shown in Fig. 2. The approximate empty weight was 44,490 kg (98,000 lb) with a structural design gross weight of 92,160 kg (203,000 lb).

Figure 2. Three-View Drawing of B-720 Airplane

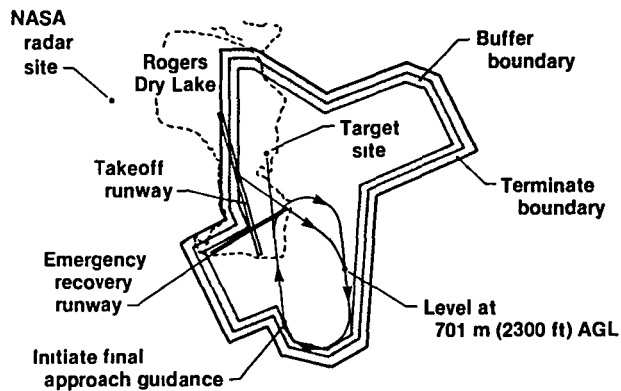
The actual CID mission profile and boundary are presented in Fig. 3. The takeoff runway was lakebed runway 17 on Rogers Dry Lake. Following takeoff, the vehicle would make a gentle left-hand turn until it intersected the racetrack at approximately 700 m (2300 ft) above ground level (AGL) which was 1400 m (4600 ft) mean sea level (MSL). With the airplane level and on the racetrack, a right turn with a radius of 1.4 n. mi. was performed with a rollout on the impact runway heading. Final-approach glideslope guidance was

The terminate boundary is shown as the light boundary on the outside of the buffer (darker) boundary. If for any reason the aircraft strayed outside the buffer boundary, a terminate command would be transmitted through an independent system. This command consisted of a full nose-down stabilizer, right rudder, engine fuel shutoff, and gear down to insure that the vehicle would impact within the sterile area indicated by the terminate boundary.

Figure 3. Controlled Impact Demonstration Ground Track and Sterile Area Boundary

Two modes of guidance information were provided to aid the RPV pilot in flying the B-720 aircraft. One mode, the racetrack guidance, assisted the pilot in flying the racetrack pattern. The second mode, final approach guidance, assisted the RPV pilot in flying the desired approach path and aided in attaining the desired conditions at impact. The racetrack and final approach patterns can be seen in Fig. 3.

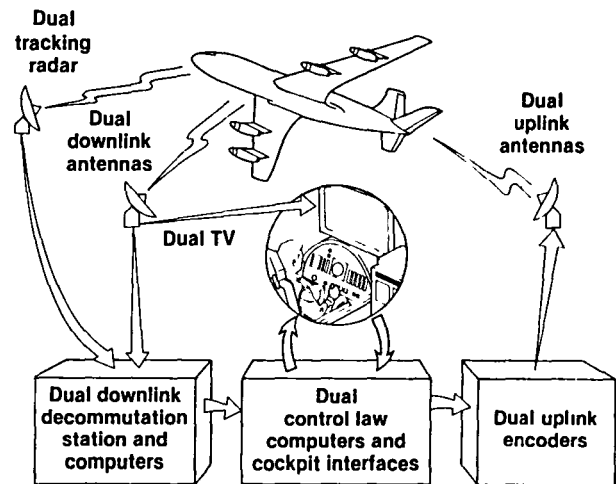
Figure 4. Controlled Impact Demonstration Ground Remotely Piloted Vehicle Control System

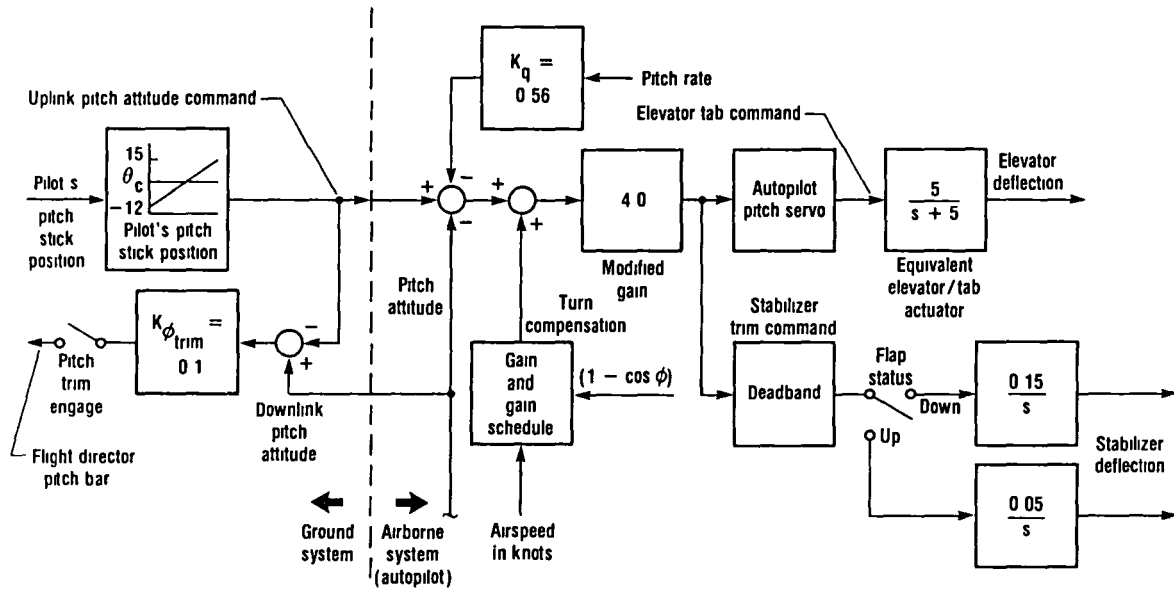
The control laws for the pitch axis are shown in Fig. 5. The RPV pilot commands pitch angle of the B-720 airplane by movement of a control stick in the ground-based cockpit. A pitch attitude command that was proportional to stick deflection was sent to the pitch axis of the PB-20D autopilot. Full stick deflection of ± 10.16 cm (± 4 in.) commanded -12° to $+15^\circ$ of pitch angle. A pitch trim button was located on the RPV pilot's stick that moved the stick at a constant rate of 2.9° of pitch attitude per second.

Figure 5 also shows how the autopilot processed the uplink attitude command. The signal was summed with pitch angle and pitch rate feedbacks, and with a turn compensation term. The autopilot generated a command to the autopilot servo, which in turn deflected the control surface through a tab-elevator system. An autotrim command was also generated which drove the stabilizer to reduce the elevator servo loads.

Figure 5. Controlled Impact Demonstration Ground and Airborne Pitch Control System

decrease in angle of attack matched the lift increase caused by ground effect. As a result of the flight tests, it was determined that the increment of lift increase caused by ground effects was significantly larger than had been predicted, while the nose-down pitching moment was about as predicted.² The result of these tests was a reduction in the autopilot inner-loop gain of 62 percent (see Fig. 5).

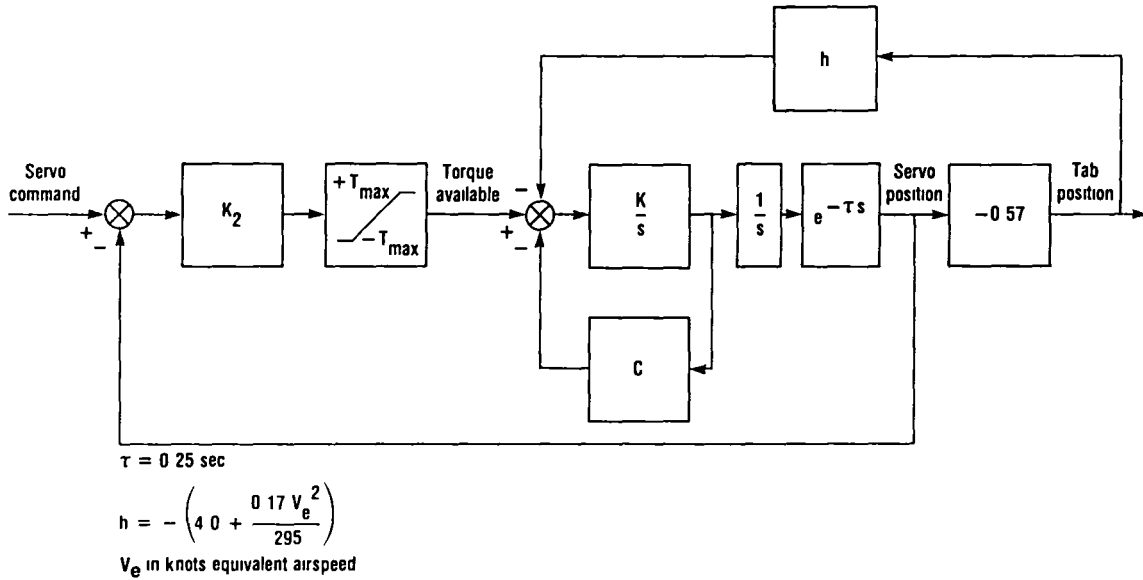
The autopilot servo model used on the simulator is shown in Fig. 6. This model was developed from a comparison of simulation and flight step responses (see Manned Test Flights section).

Figure 6. Controlled Impact Demonstration Autopilot Pitch Servo Model

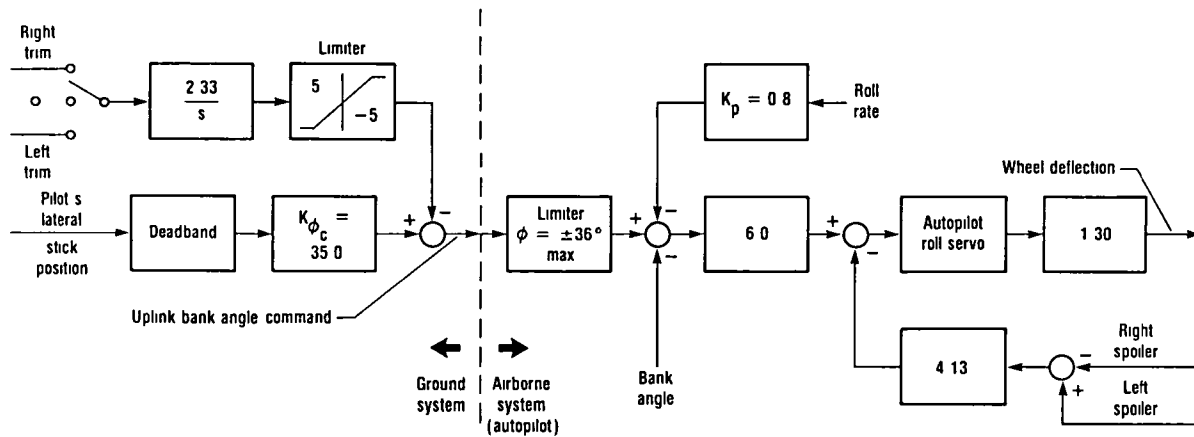
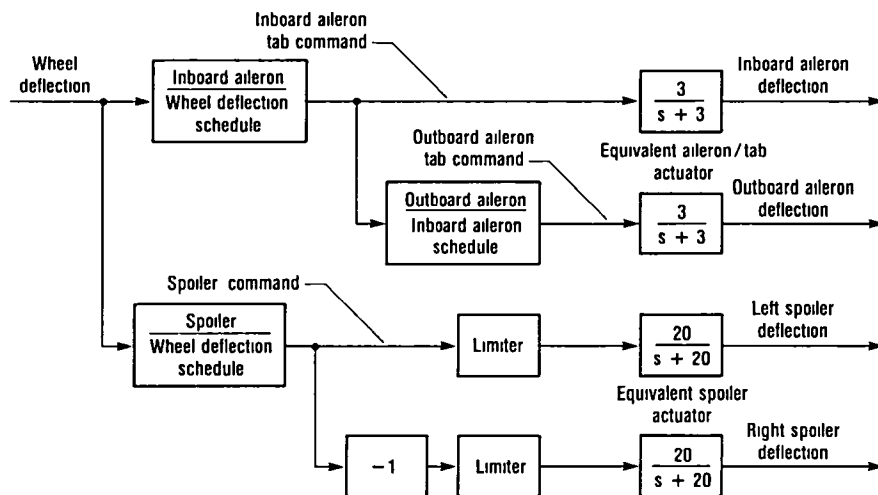
The ground-based and onboard autopilot control laws for the roll axis are shown in Fig. 7. The RPV pilot commanded roll attitude of the aircraft proportional to the lateral displacement of the control stick in the ground-based cockpit. The pilot inputs went through a small deadband and generated commands which were uplinked to the roll axis of the onboard autopilot. Full deflection of the roll stick (± 10.16 cm (± 4 in.)) commanded $\pm 35^\circ$ of bank angle.

(a) Ground to Wheel Command Path

(b) Wheel to Aileron and Spoiler Command Path

Figure 7. Controlled Impact Demonstration Ground and Airborne Roll Control System

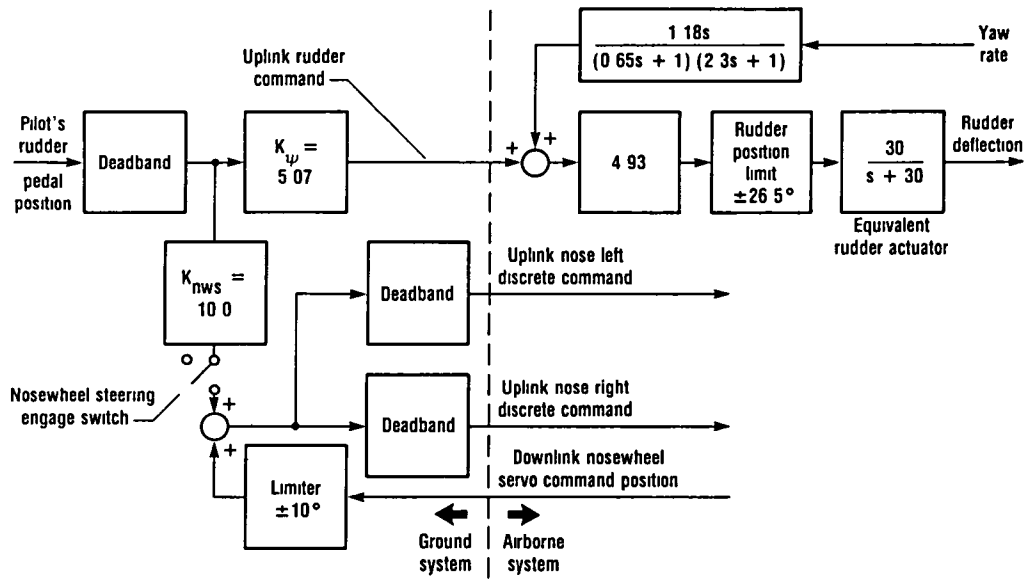
The RPV pilot commanded rudder to the B-720 aircraft through the yaw damper. The RPV rudder control system is shown in Fig. 8. The rudder pedal position signal was passed through a deadband, and a rudder command proportional to pedal deflection was uplinked to the airplane. Full rudder pedal commanded $\pm 25^\circ$ of rudder deflection.

Figure 8. Controlled Impact Demonstration Ground and Airborne Yaw Control System

A diagram representing the implementation of the ground-based cockpit's nosewheel steering system is also shown in Fig. 8. The RPV pilot generated a nosewheel position command that was proportional to rudder pedal displacement when the nosewheel steering was engaged. This command was then compared to the downlinked nosewheel servo-position command. A nose-left or nose-right discrete command was uplinked to the onboard RPV nosewheel steering system motor. This motor then

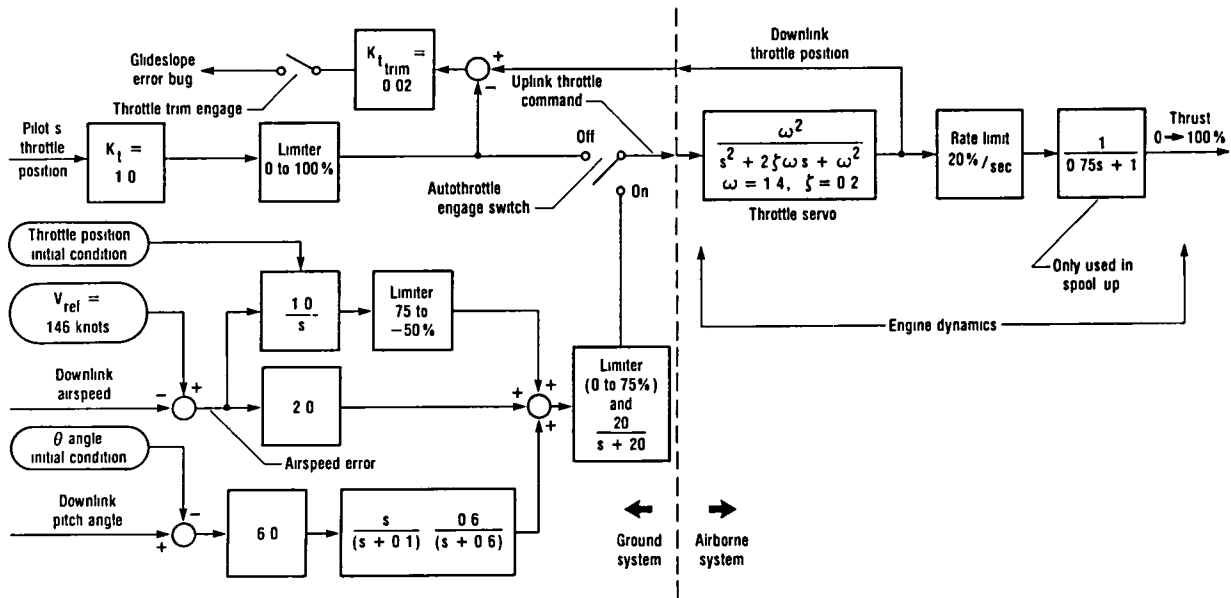
Figure 9. Controlled Impact Demonstration Ground and Airborne Throttle Control System

The RPV pilot commanded the throttle to the airplane through a single lever in the RPV cockpit. An autothrottle was provided in the ground-based software to free the RPV pilot from making throttle adjustments during flight. Figure 9 shows the mechanization of the ground cockpit throttle system, the autothrottle implementation, and the simulation model of the engine dynamics. The throttle was limited to a range between 68-percent engine rpm (idle) and maximum throttle.

The autothrottle was engaged to hold indicated airspeed at a prespecified value. A reference airspeed of 146 knots was selected to obtain the desired true airspeed of 152.5 knots at impact, after passing through ground effect. The airspeed that the autothrottle controlled was the downlinked, onboard-computed airspeed (V_{cas}). This downlinked airspeed was compared to the reference airspeed to generate an airspeed error. This error signal was passed through a proportional and an integral path. The integrator was initialized at the current value of the pilot throttle lever position and was limited to a -50 percent to +75 percent range to prevent saturation if the autothrottle was engaged at an airspeed that was significantly different than the reference speed. A filtered, pitch-angle term was used to lead the throttles when the flightpath was changed. The autothrottle command was limited to a range of 0 percent to 75 percent (approximately maximum continuous thrust). This command was uplinked to the B-720 throttle system.

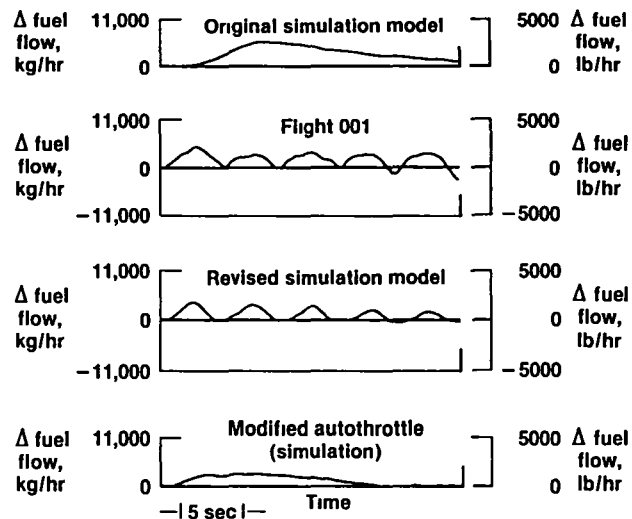
Figure 10. Comparison of Flight and Simulation Engine Fuel-Flow Response to an Autothrottle Step Input

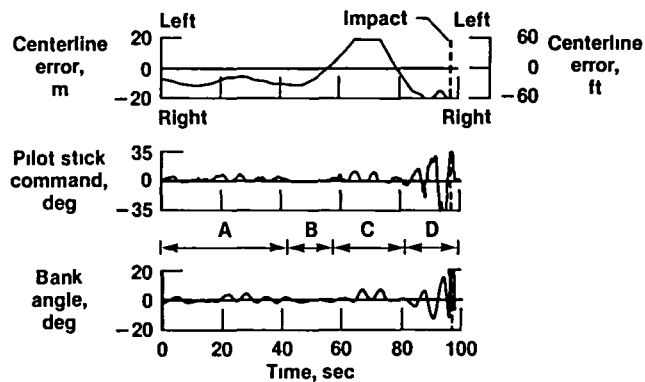
Some of the pertinent lateral-directional parameters near impact are shown in Fig. 11 and the longitudinal parameters are shown in Fig. 12. The time histories are broken into four regions (A to D), based on lateral activity, as shown in the figures.

Figure 11. Lateral-Directional Time Response From 498 m (1630 ft) AGL to Impact

Region B. In region B, the RPV pilot stopped making any significant lateral corrections for about 10 sec. This occurred while he was working the longitudinal task since the altitude error was increasing significantly immediately before region B, and was reduced to an acceptable level by the end of the region B. It could have also been caused, in part, from the need to transition between the TV visual display and the cockpit instruments in order to cross check the validity of the guidance information. Whatever the reason, during this time period without any pilot inputs, the roll bias produced a left turn (about a 2° bank). This, in turn, caused the lateral deviation to start moving rapidly to the left (rapidly in terms of the 4.6 m (15 ft) constraint). The actual crossrange drift rate was about 0.9 m/sec (3 ft/sec) at the end of region B.

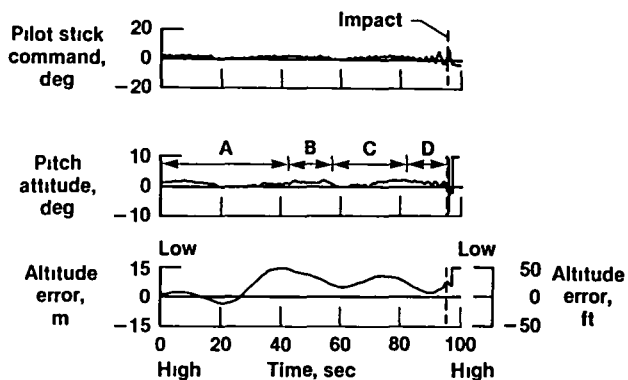
Figure 12. Longitudinal Time Response From 498 m (1630 ft) AGL to Impact

In the pitch axis, the pitch angle was held within the desired range (0 to 2°) during this final region, although it was oscillating. The pitch command was oscillatory and diverging. The altitude error was converging on the desired value until the large bank angles occurred. At this point, altitude was lost because of slight pushover (about 1°) and the lift loss caused by the banking. This resulted in the impact being short of the desired point.
